LIGHTNING PROTECTION AND LIGHTHOUSES

R P Dugher

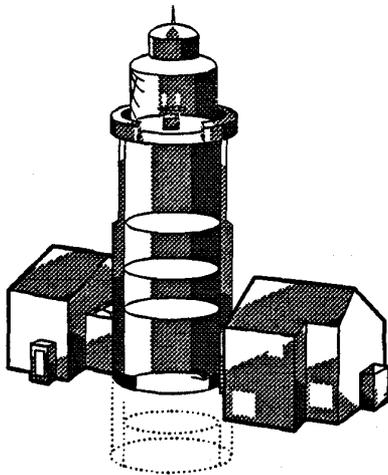
START POINT LIGHTHOUSE

On the 18 January 1995, the monitoring station at St. Catherine's lighthouse reported loss of telemetry and the Attendant was dispatched from his home in Kingsbridge, 7 miles away, to investigate. On arrival he noted that the main light was extinguished and the emergency light operating. The standby generator was running providing lighting in the tower. Some domestic electricity supplies were operational but all circuit breakers in the tower were tripped. There was a strong smell of burning in the tower. Telephone wires were burnt out and junction boxes blown apart. The mini exchange was destroyed. The telemetry unit had an adjacent telephone line surge arrester, this was 6m from the point at which the cables entered the tower. The internal modem was damaged as was the digital interface board. The fire and intruder detection systems were inoperative.

The generator main fuel storage tank is located on the base of the old (removed) three phase mains transformer about 6m from the north dwelling. Plastic conduit containing the fuel level sensor conductors was blown apart at the fuel tank end. A large chunk of concrete was blown from the transformer base, exposing the old transformer cables. Tarmac was displaced on a footpath where the S.E. lightning earth conductor crossed the path of a disused underground power feed to the old fog signal and generator building.

Aluminium flashing around the tower at south passageway roof level was damaged. Structural damage occurred to the eaves wall at roof level of the south dwelling where the down conductor turned upwards(!) and over the pitched roof.

While there was no evidence of actual structural damage to the tower, there were signs of side flashing from the sector light pedestal mountings to a suspended ceiling below and from the suspended ceiling to the vertical cable tray. Arcing had also occurred between the cable tray and telephone cables and to equipment housings.

- Damage to the standby generator control circuits caused the generator to start (not the failure of the mains).
- Battery charger control circuit boards were faulty;
- The mini telephone exchange had a hole burnt in the cover (and, presumably, in the printed circuit inside);
- Considerable damage was evident on the printed circuit cards in the navigation light control cubicle;
- There was evidence of arcing from a cable tray to the metalwork of the navigation control cubicle;
- The fog detector on the gallery parapet had failed.

- The down conductors were not bonded together at the base of the tower, nor was there a cross bond to the bottom of the weight tube which is bolted to the foundations of the tower;

- The connection to the radiobeacon earth mat is in place but was isolated from the building;
- The incoming and outgoing mains were not directly bonded to the lightning protection system;

- Only one telephone line surge arrester had been fitted, located a long way from any suitable earth point. The incoming and outgoing telephone lines of the mini exchange were unprotected;

- Various isolated sections of cable tray were bonded with short 4mm earth wires, one gap did not appear to be bridged at all;
- The cable tray is connected to the metal lantern floor at the top but was not connected to the lightning protection at the bottom;

- When the middle section of weight tube was removed, bonds to the staircase handrails were inadvertently isolated;
- Many metal equipment cabinets were not correctly bonded to the cable tray;

- The telemetry and navigation light control cubicles are of plastic construction and therefore do not offer any screening. The metal backplanes of these were not properly bonded to the cable tray;

- The fog detector was not bonded to the lightning protection system.

These findings were communicated to the maintenance department and remedial action put in hand. Since the work was completed there have been two instances of surge arrester failure on the telemetry telephone line, possibly suggesting further strikes to, or near the lighthouse. One of these failures coincided with a damaging strike at Nash Point lighthouses in South Wales.

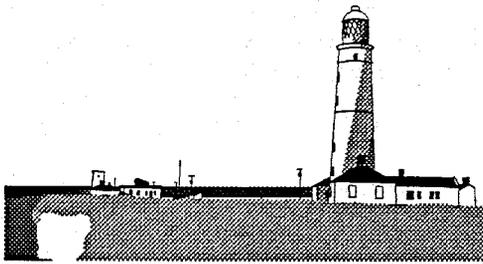
NASH POINT LIGHTHOUSE

The GPS aerials on the roof of the lighthouse were struck by lightning on the 10 July 1995. Scaffolding around the disused low light tower and a pole near to a dwelling were also struck.

There are no reports of structural damage. An aerial tuning unit located at the radiobeacon aerial and a pole mounted telephone junction box were the only external items of equipment to be damaged. A mains detection relay was the only equipment damaged in the engine house.

Service room: VHF telemetry receiver and modem;
Fifth floor: GPS satellite receivers, monitor PC, modem and radiobeacon RF modulators;
Watch room: Equipment connected to telephone lines: Remote telemetry monitoring processor and communications cards; Telemetry PC; Facsimile machine; Mini telephone exchange; One extension telephone.
Equipment not connected to telephone lines: Cellphone and power supply; Marine VHF transceiver; Radiobeacon transmitter; Radiobeacon battery charger;

- A section of the old, internal down conductor has been removed in the service room isolating it from the cast iron lantern;
- The internal and external down conductors are not joined at the bottom;
- Surge protection is not provided for the incoming and outgoing electricity or telephone cables;
- The radiobeacon earth mat is not bonded to the lightning protection earth;
- Radio aerial feeder cables were not bonded to the station earth;
- Surge protection was not provided on the long signal cables between the GPS reference equipment (fifth floor) and the radiobeacon transmitter in the watchroom;
- Surge protection and screening of the control cables between the radiobeacon and the aerial tuning unit is needed.
