THE MINARET INCIDENTS AT PUTRAJAYA

**The “Ultimate Test” Case for the Early Streamer Emission
Technology & Standard**

By
Z. A. Hartono & I Robiah
October 2010
E-mail: zahartono@ieee.org

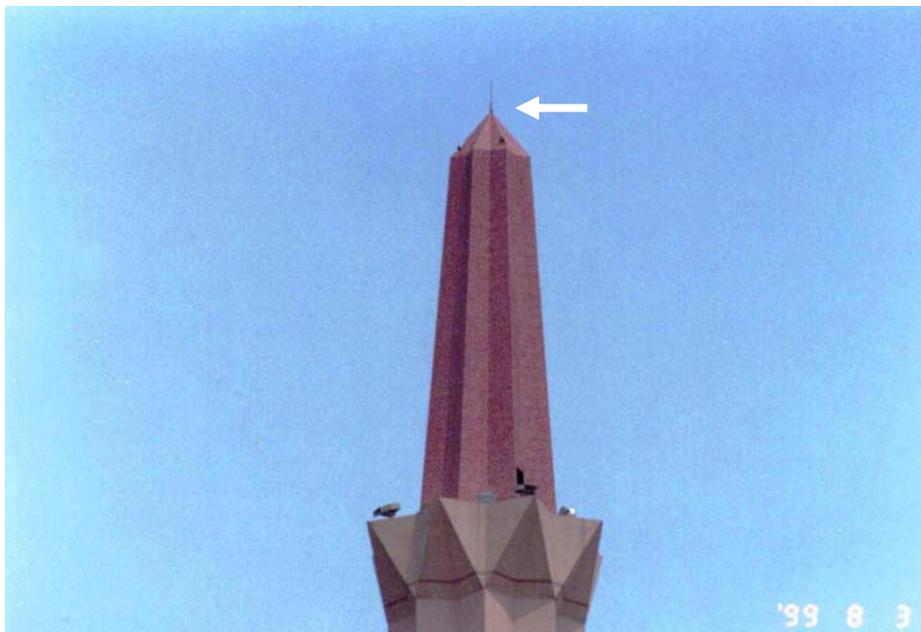
Figure 2: Close-up picture of the minaret reveals a Helita Pulsar ESE lightning air terminal installed on the apex.

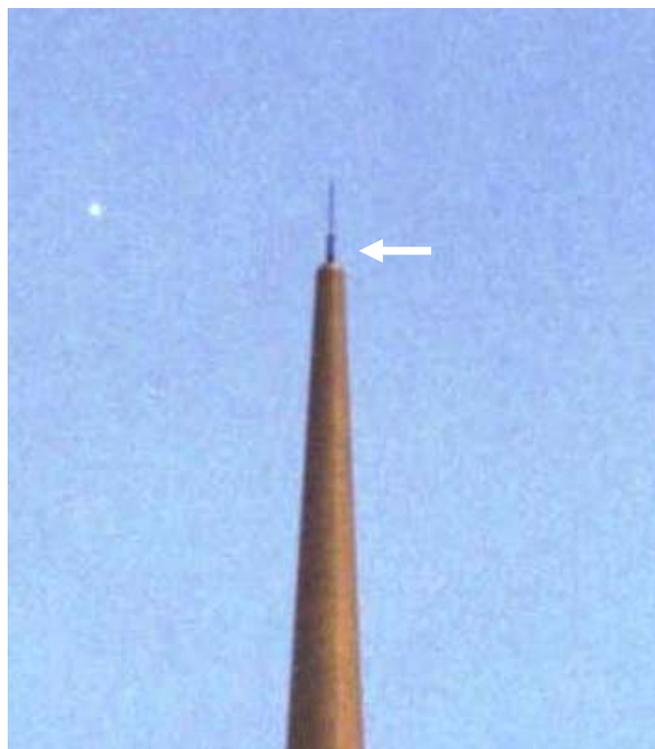
Another Helita Pulsar ESE air terminal was also installed on the apex of the spire erected on the dome of the mosque (Figs. 3 and 4). This indicates that the ESE air terminal that was installed on the minaret was designed for the protection of the minaret only.

Figure 4: The Helita Pulsar ESE air terminal on top of the spire of the Putra Mosque dome.

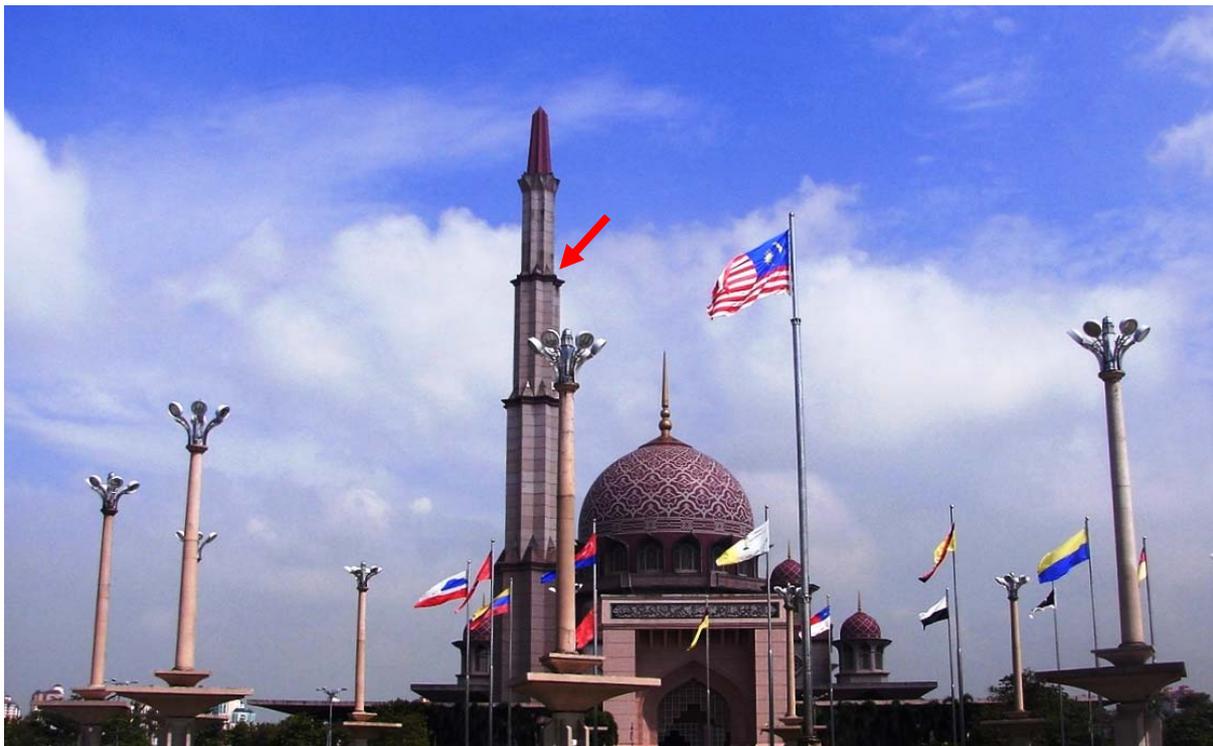
In March 2005, lightning struck and damaged the tip of one of the triangular marble protrusions on the side of the minaret. The bypass was located about 30 metres below the apex (Fig. 5).

The lightning stroke broke off a marble slab which fell to the base of the minaret. This incident has been described in an article that was published in the Journal of the Association of Consulting Engineers Malaysia in 2007.

Figure 5: The arrow points to the location of the lightning damage in the 2005 incident.

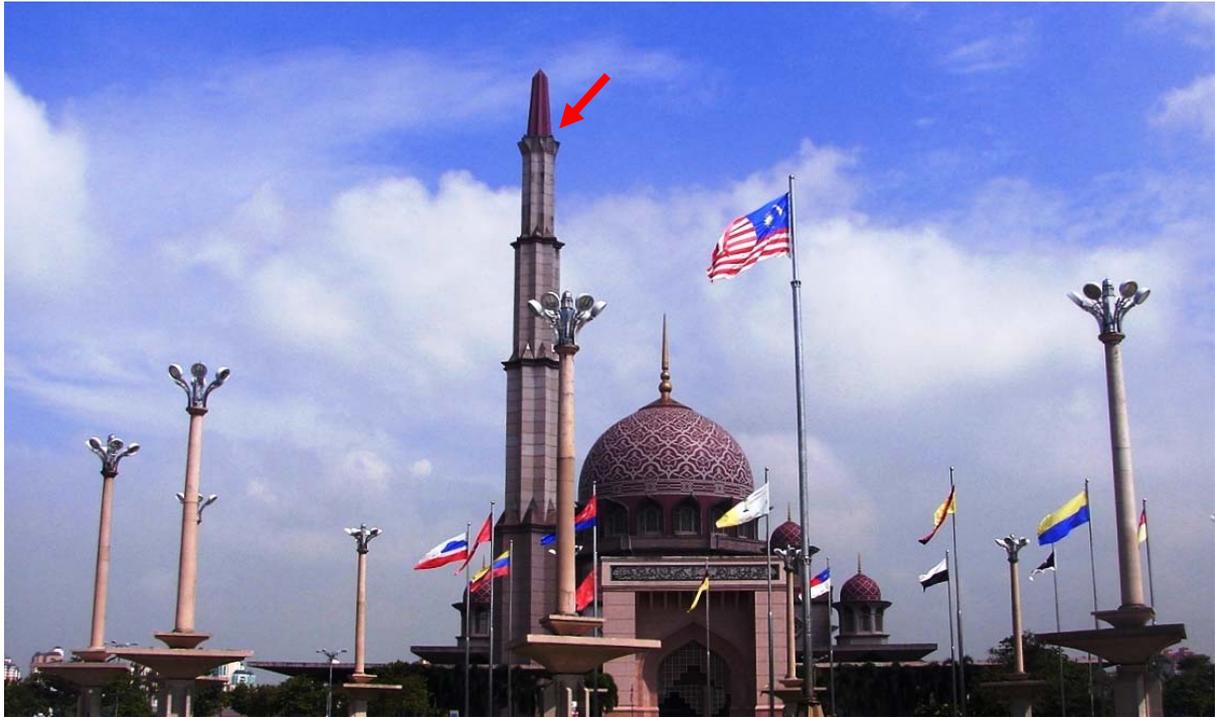
In September 2010, lightning again struck and damaged one of the protrusions on the side of the minaret. This time, the bypass was located on the tip of one of the triangular concrete protrusions about 12 metres below the apex (Fig. 6). A significant portion of the concrete protrusion was broken off by the lightning stroke. Parts of the debris also knocked off a section of a marble slab from one of the lower protrusions below it.

Figure 6: The arrow points to the location of the bypass in the September 2010 incident.

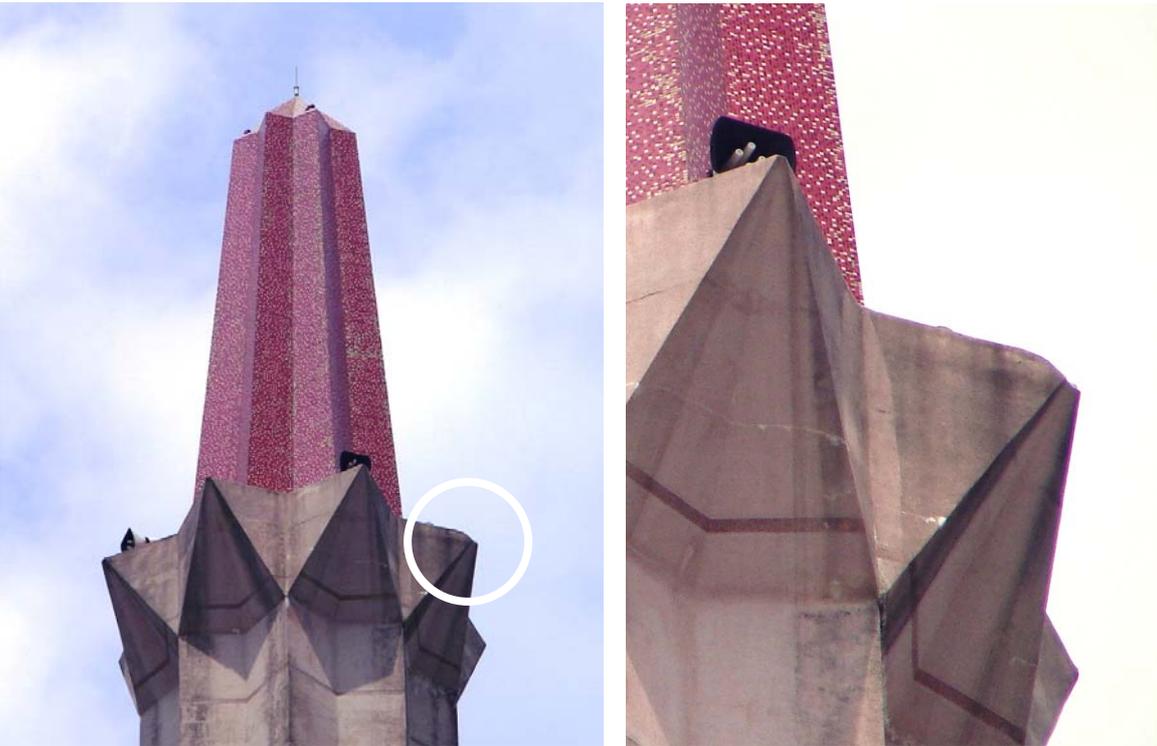
The bypass to the concrete protrusion can be seen in the pictures below (Fig. 7). This kind of bypass is similar to those that were observed at the corners of numerous lightning damaged buildings around the country.

Figure 7: The location of the bypass (left) on the horizontal concrete protrusion and a close-up view of the same bypass (right). Compare this photo with that of Fig. 2 (before the strike). The Helita Pulsar ESE air terminal can be seen on the apex of the minaret about 12 metres above the bypass.

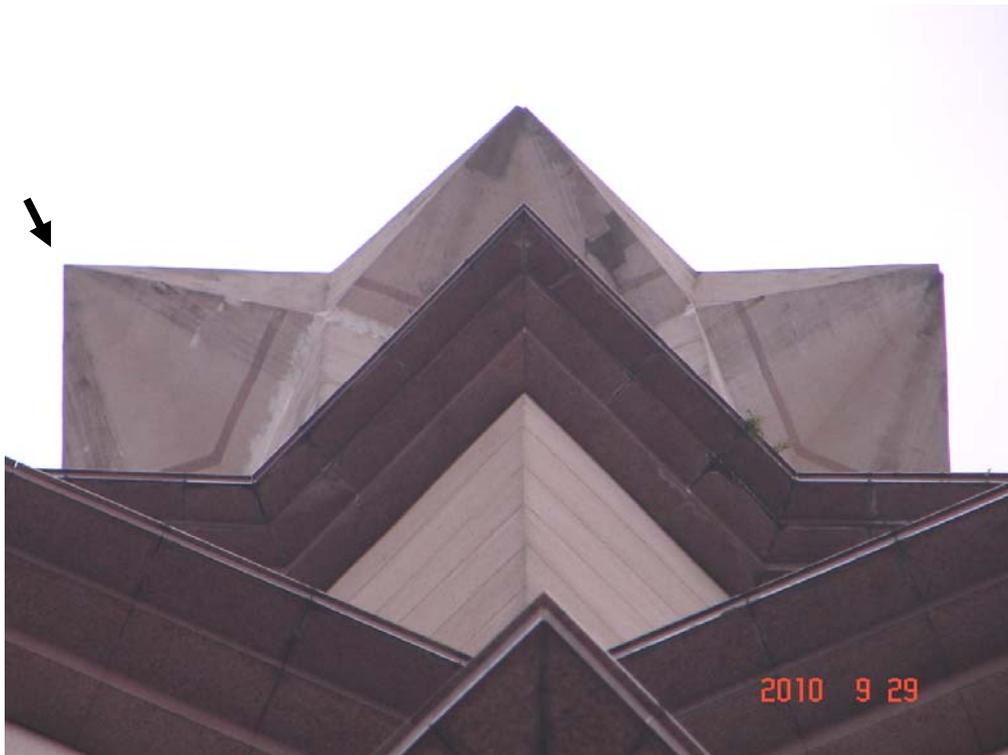
The horizontal concrete protrusions below the apex originally have pointed tips when the minaret was first completed in 1998. Of the original eight pointed tips which were constructed in an eight-pointed star formation, only one remains undamaged (Fig. 8).

From observations made to other buildings in the country, it is very difficult to detect the effects of a second lightning strike to an existing bypass unless the second strike causes a much bigger damage which drastically alters the shape of the original bypass. This suggests that the minaret have been struck at least eight times in the past dozen years since it was installed with the ESE air terminal.

Figure 8: A close-up photo showing three of the concrete protrusions taken from the base of the minaret. Two of the protrusions displayed minor damages while the only remaining undamaged protrusion is shown on the left.

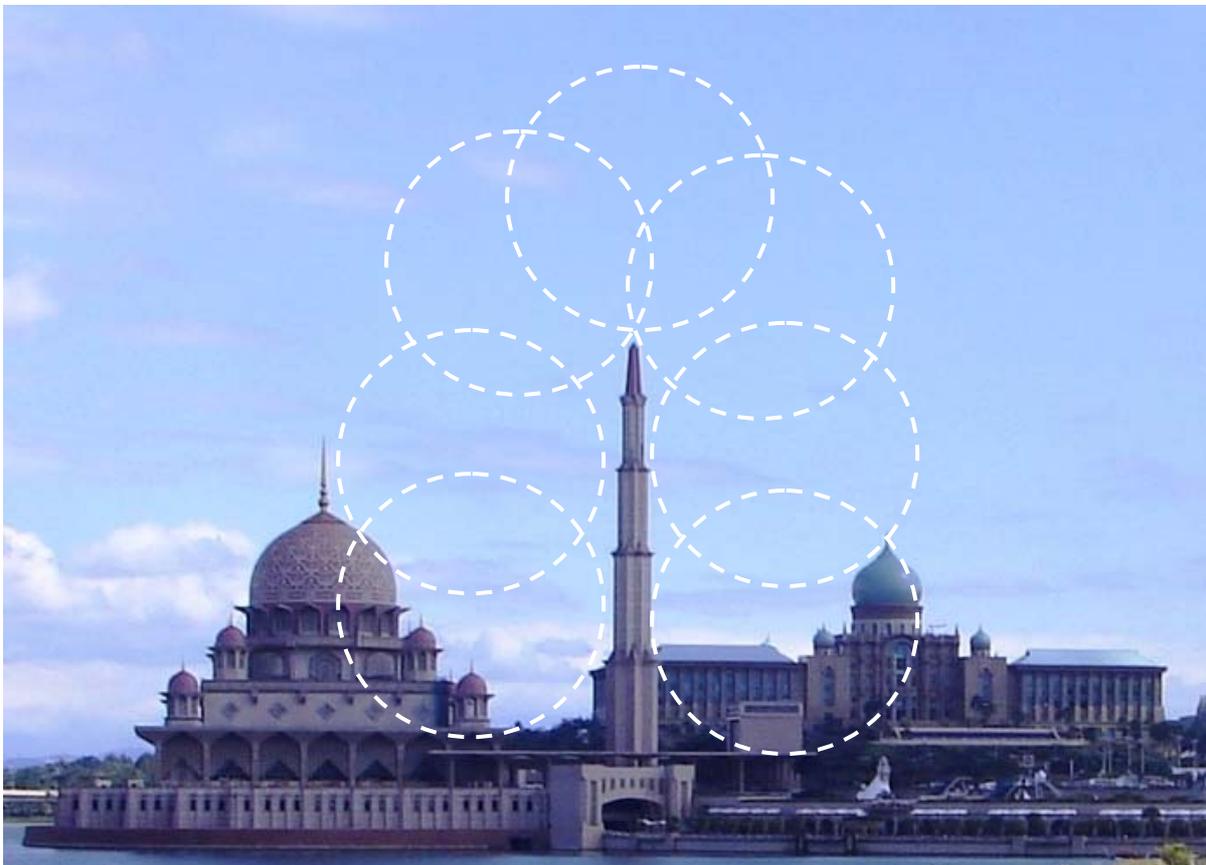
In this method, an imaginary sphere is rolled over and around the structure (eg. minaret) to be protected (Fig. 9). The surfaces of the minaret that are at risk of being struck by lightning, and hence require protection, are those that come into contact with the imaginary sphere, such as the apex and the tips of protrusions along the sides of the minaret.

Figure 9: The rolling sphere method applied to the minaret. The method predicts that the sides of the minaret can be struck by lightning.

The RSM predicts that the majority of the lightning strikes in the vicinity of the minaret will occur at the apex. The RSM also predicts that lightning can strike the minaret below the apex and the observed bypasses to the protrusions validated this method.

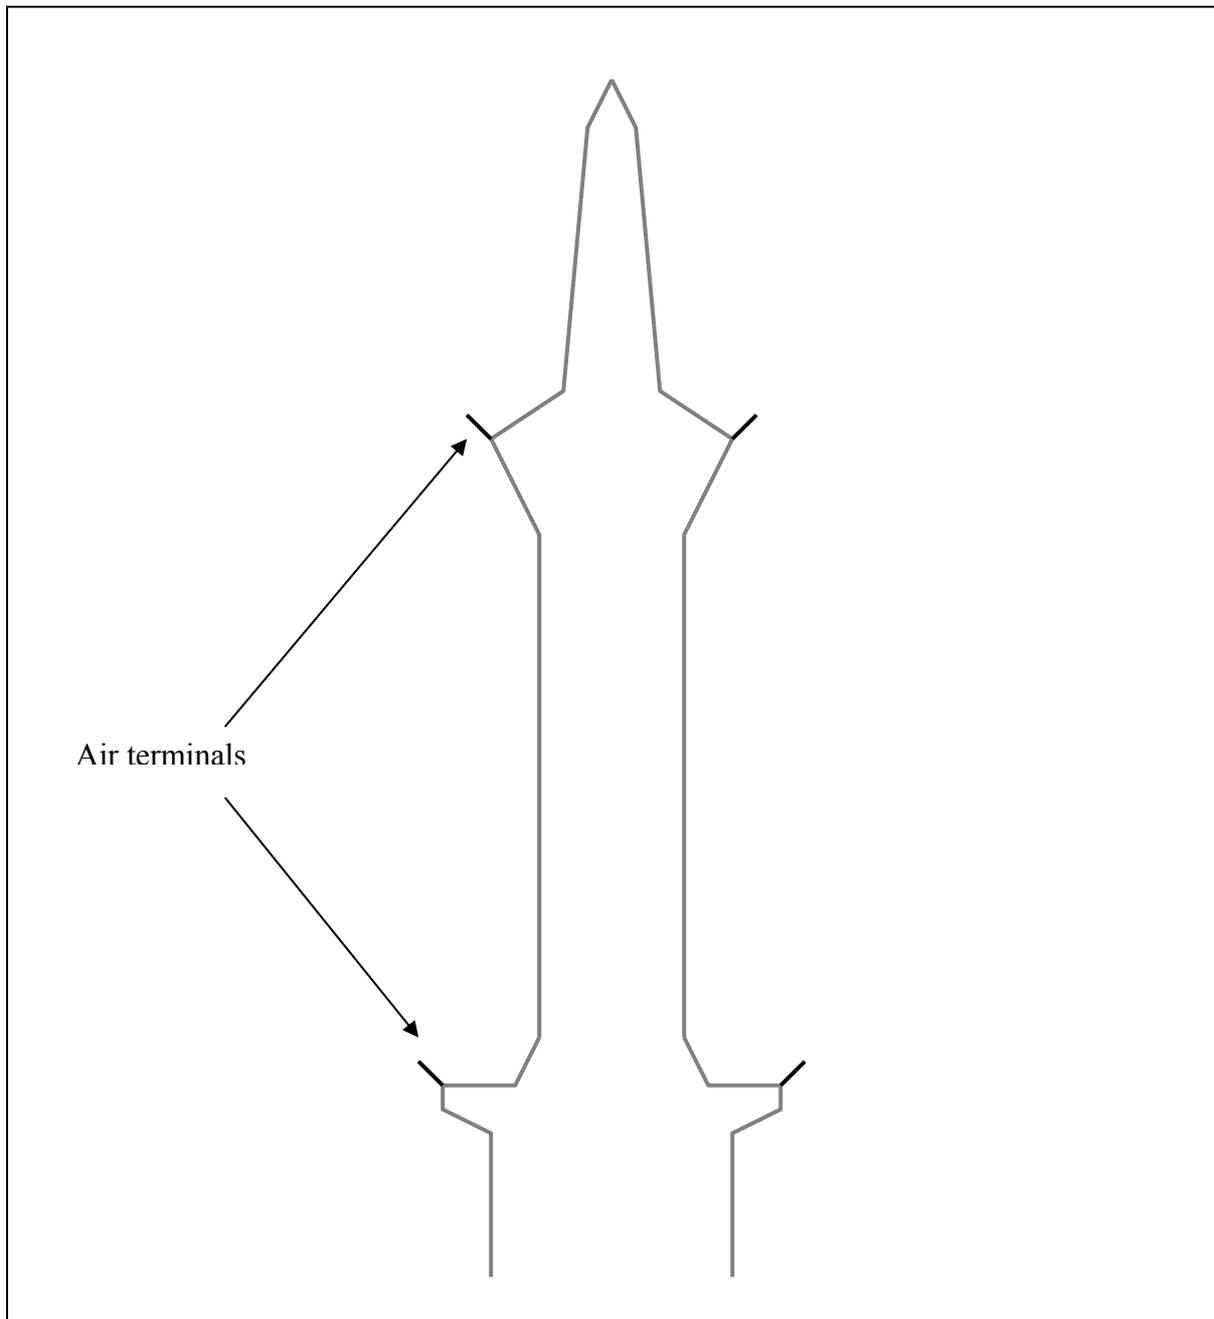
Figure 10: Vertical cross-section of the upper minaret showing the recommended position of conventional air terminals on the protrusions.

Hence, in order to protect the minaret from further damages, conventional air terminals (i.e. lightning rods) should be installed at the tips of all protrusions on the sides of the minaret. To effectively receive the lightning stroke, the air terminals on the protrusions should be pointing outwards and slanted slightly upwards at an angle. This is shown in the diagram below (Fig. 10). These air terminals can be bonded to the structural reinforcement steel bars for continuity to ground.

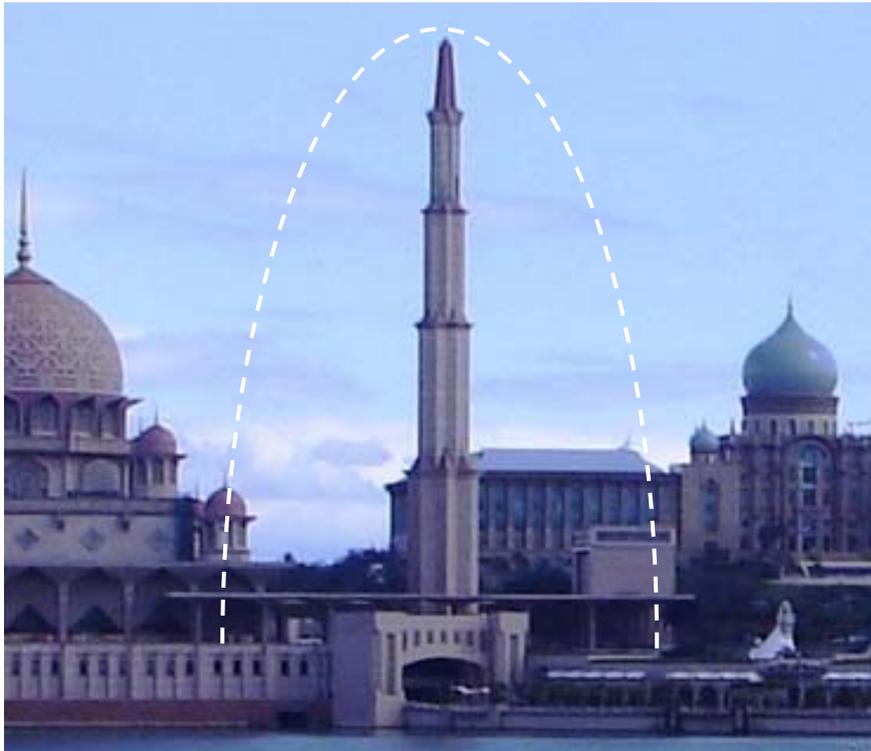
According to the ESE standard, the protection zone starts at the tip of the ESE air terminal and takes the shape of an umbrella as it drops below the tip (Fig. 11). The radius of the protection zone at a particular height below the tip is determined by a specified mathematical formula found in the standard. At a height of about 30 metres below the tip of the ESE air terminal, the radius of the claimed protection zone should be at least 25 metres (protection level 1).

The average radius of the minaret at 30 metres below the apex is less than 5 metres, hence all the protrusions are deep within the claimed ESE protection zone. Therefore, the minaret is the ideal “ultimate test” case to validate the ESE standard, NF C 17-102.

However, the repeated failure of the ESE air terminal to prevent bypasses to the protrusions clearly suggests that the claimed ESE protection zone is non-existent and that the ESE air terminal positioning method described in the ESE standard is invalid and dangerous to apply on real buildings.

Figure 11: The dashed line indicates the claimed protection zone, according to the ESE standard NF C 17-102, of the ESE air terminal which was installed at the apex of the minaret.

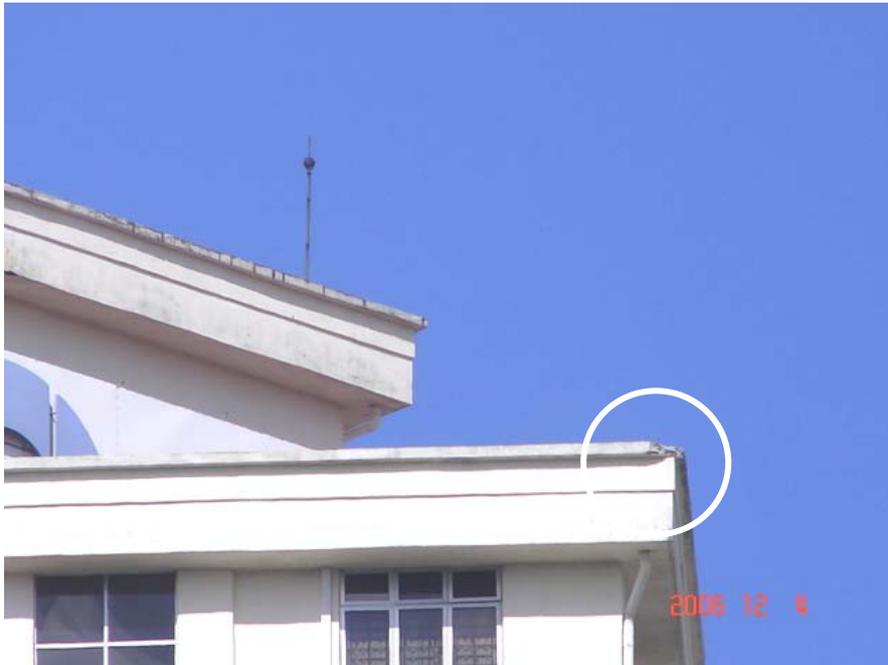
Figure 12a

The bypasses that occurred on the minaret of the Putra Mosque are not unique events since dozens of other similar bypasses have been observed and photographed on other buildings. They occurred well within the claimed protection zones of the ESE air terminals. A few examples of these bypasses and the nearby ESE air terminals are shown below (Figs. 12a to 12d):

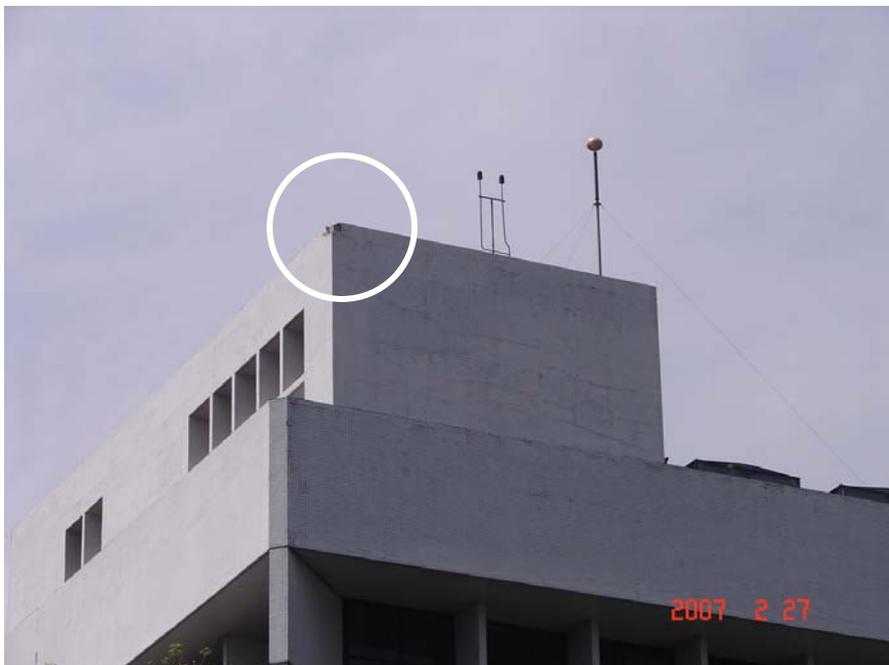
Figure 12d

The example below shows an ESE air terminal whose positioning method follows a different design method called the Collection Volume Method (CVM). The application of the CVM has also resulted in numerous bypasses on tall buildings in Malaysia. Some of these bypasses were found to be very close to the air terminals as shown in the example.
