THE BELL TOWER INCIDENT AT SIGOLSHEIM

**A Very Compelling Evidence for the Failure of the
Early Streamer Emission Technology & Standard.**

By
Z. A. Hartono & I Robiah
September 2010
E-mail: zahartono@ieee.org

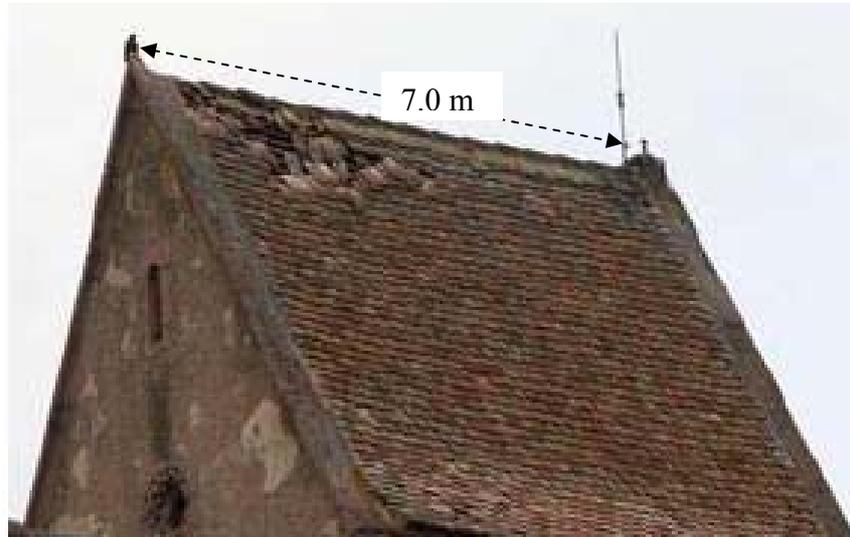
According to the Dernières Nouvelles D'alsace (DNA) News article dated May 29, 2009, lightning had struck the stone cross of the bell tower at 11.20 pm on May 21, 2009. The damaged cross fell through the roof tiles and subsequently damaged the interior of the bell tower (Figure 3). The article also mentioned that the ESE air terminal had been inspected annually and therefore should have been functioning properly at the time of the incident.

Figure 3: The bell tower of the Saint Pierre and Paul church in Sigolsheim soon after the lightning strike incident. The Helita Pulsar 25 ESE air terminal is at the right. (Photo: DNA News)

A study was conducted by the Chambre des Experts Agrées, Communauté Européenne (CEACE) to determine the cause of the lightning strike to the stone cross. The CEACE report no. 8024213399-59 mentioned that the length of the bell tower roof was 7.0 m and the distance between the stone cross and the Helita Pulsar 25 air terminal was less than 6.0 m. The report also mentioned that the tip of the air terminal is 0.9 m higher than the cross and that the air terminal did not exhibit any signs of lightning interception. This suggests that the air terminal had never been struck by lightning before the May 2009 event.

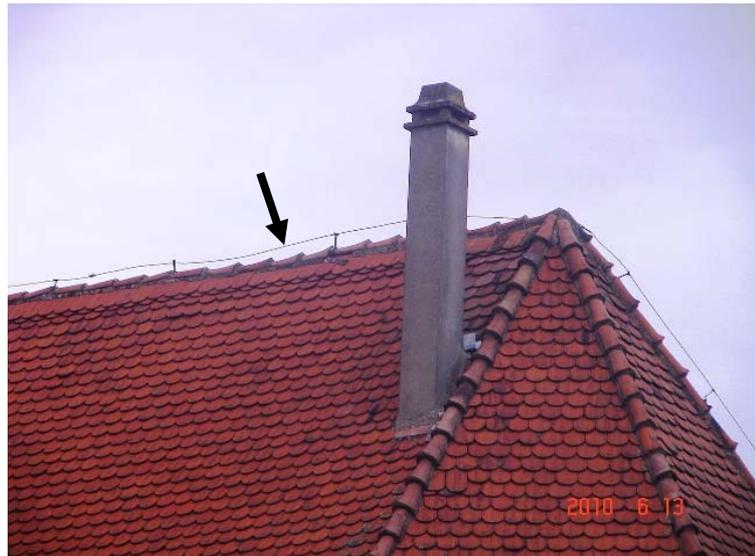
Figure 8: Magnified pictures of the church showing an ESE lightning air terminal (left) and a conventional air terminal (right) installed on the roof.
