WARREN LIGHTNING ROD COMPANY

Galvanic Corrosion in Lightning Protection Applications – Problems & Solutions

By Simon C. Larter

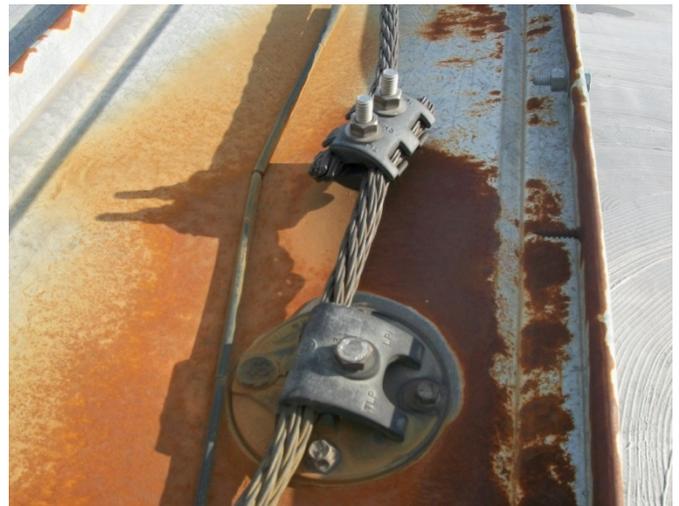
Figure 1: Copper and bronze in contact with galvanized steel.

Historically, copper and bronze materials have been used in lightning protection applications on all rooftop surfaces other than aluminum, due to their excellent conductivity, thermal characteristics, and longevity. A properly installed lightning protection system (LPS) will last for decades, maintaining its integrity with only minor maintenance, in the absence of additions to the protected structure or reroofing projects. However, while the LPS materials retain their effectiveness even after oxidation, the same cannot be said of the roofing materials to which they are often attached. Indeed, copper and bronze components in contact with exterior galvanized or painted steel surfaces can cause significant corrosion over time (see Figure 1), an effect only partly mitigated by traditional methods such as repainting.

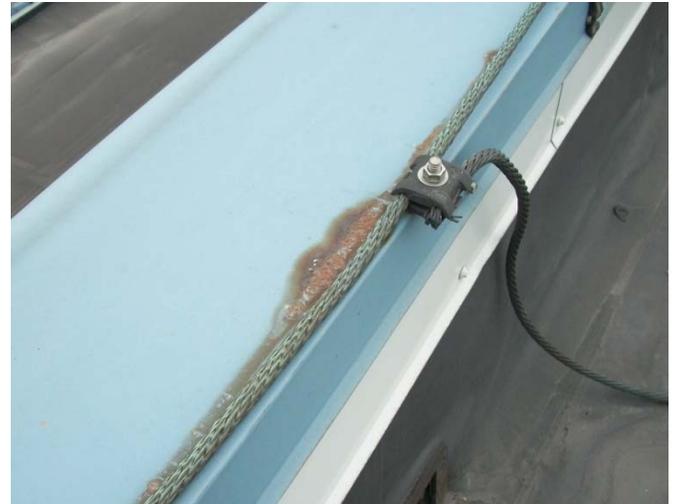
Figure 2: Copper and bronze in contact with painted steel.

Though this action on UL's part was unpopular with both installing contractors and building owners, it is clear that galvanic corrosion can and will occur where copper and steel in contact are exposed to an electrolyte fluid (which for our purposes is assumed to be rainwater). Figure 2 shows the deterioration that can occur when copper conductor is run on a painted steel coping.

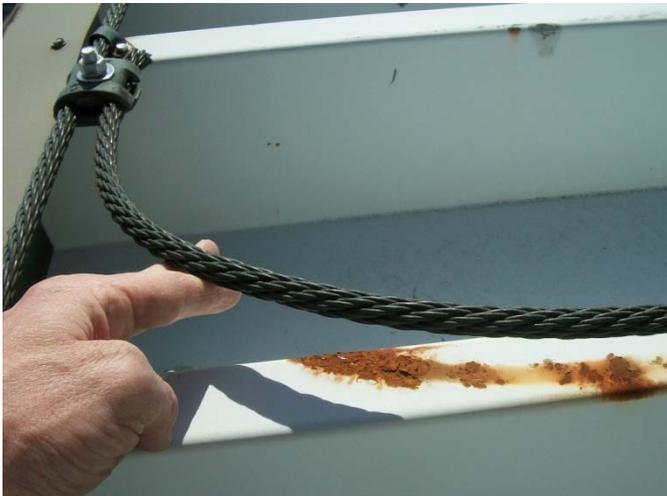
Figure 3: Copper in contact with a standing-seam metal roof.

For locations such as perimeter copings, degradation of the metal may not pose an immediate threat to the building contents. Roofing membranes typically wrap up and over parapets, providing a secondary layer of waterproofing, so that infiltration even in the event of corrosion through the coping will be nominal, at best. In the case of standing-seam roofs, on the other hand, the metal itself is the primary infiltration barrier. Holes corroded through this type of roof will expose equipment and personnel within the structure to moisture. The author has observed instances of almost complete corrode-through in systems less than 20 years old. Figure 3 shows the corrosion of a metal, standing-seam roof after less than 15 years of contact with bare copper conductor.

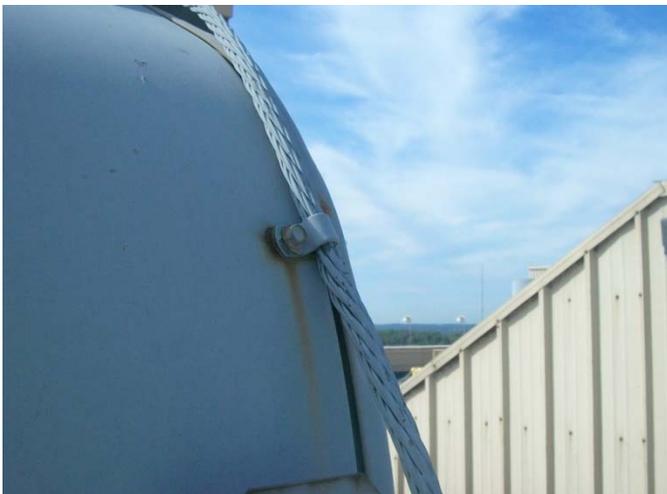
Figure 4: Corrosion between painted unit and painted conductor

system can bring corrosion issues to light before significant deterioration occurs, and painting of affected surfaces can slow the oxidative process. As Figure 4 shows, though, painting will not fully prevent rust from forming. Because lightning conductor is generally braided, wicking of moisture through the interstices is impossible to prevent. There will always be infiltration, and therefore there will always be some amount of corrosion.

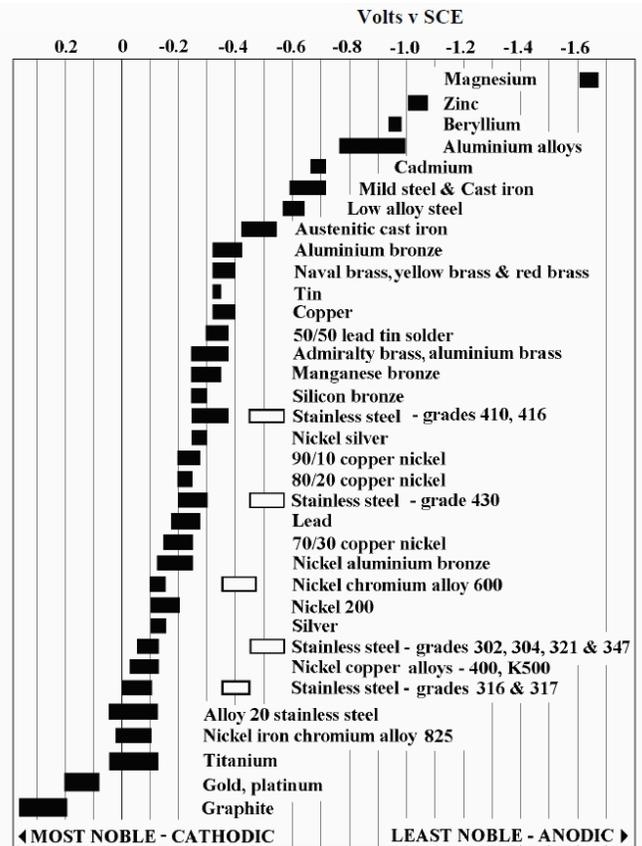
Figure 5: The galvanic series
(Source: [Atlas Steels Technical Note No. 7](#))

The aforementioned corrosion issues often do not pose any threat to the functionality of the lightning protection system. Although the surfaces to which the LPS components are attached may degrade, copper being more noble than steel or aluminum (see Figure 5 below) means that there will be very little impact to the efficacy of the main conductor. However, lightning protection does not exist as a separate system, but as an integral part of the overall building envelope. As such, it cannot be viewed in isolation, and a building owner should not be asked to sacrifice the integrity of their roofing system for the sake of a lightning protection system whose value can only be realized in the event of a direct strike to the building—an event that may only occur once every few years.

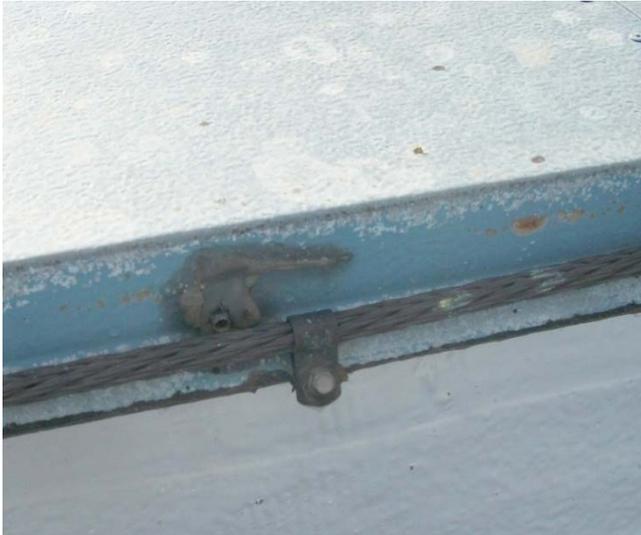
Figure 6: Copper side-mounted on painted steel.

The installation pictured in Figure 6 is a side-mount copper and bronze system affixed to a painted steel

coping. Even though the mounting surface is vertical, and offers little opportunity for moisture to accumulate, rust is easily noticeable where the conductor was held against the cap (the fastener in this instance worked loose, allowing the cable to fall away and expose the substrate).

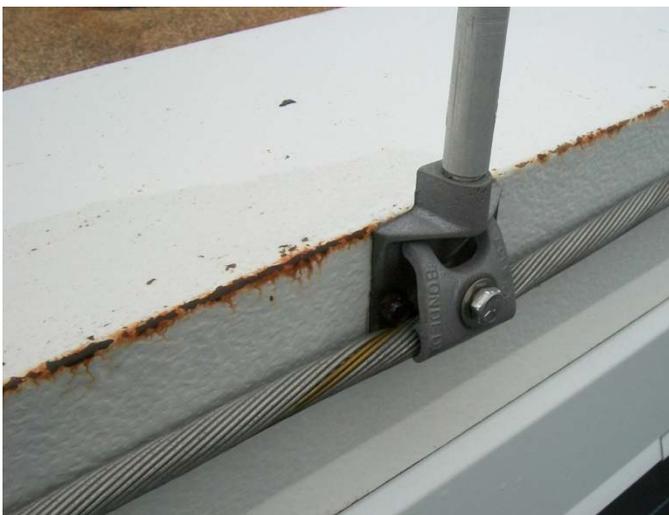
Figure 7: Aluminum side-mounted on painted steel.

A counterexample is provided in Figure 7. Here, the installation is also side-mounted on a painted steel cap, but the materials are aluminum. We can see that despite the visible rust at the edge of the coping, there is no noticeable corrosion beneath the conductor, nor behind the air terminal base. The age of the system is similar in both instances.
