THE MINARET INCIDENTS AT PUTRAJAYA

**The “Ultimate Test” Case for the Early Streamer Emission
Technology & Standard**

By
Z. A. Hartono & I Robiah
October 2010
E-mail: zahartono@ieee.org

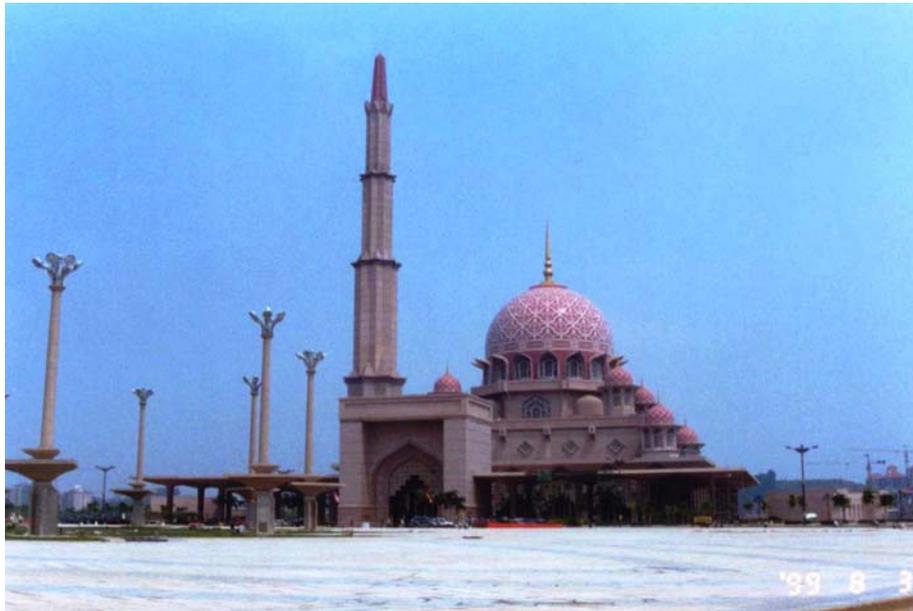
The Putra Mosque is located in Putrajaya, the new administrative capital of Malaysia which is located about 25 km south of Kuala Lumpur. The annual thunder day (TD) level at this location is about 200. The mosque was completed in 1998 and has a 116 metre high minaret which has been installed with a Helita Pulsar ESE air terminal (Figs 1 and 2).

Figure 1: The Putra Mosque and minaret taken from the “circle”.

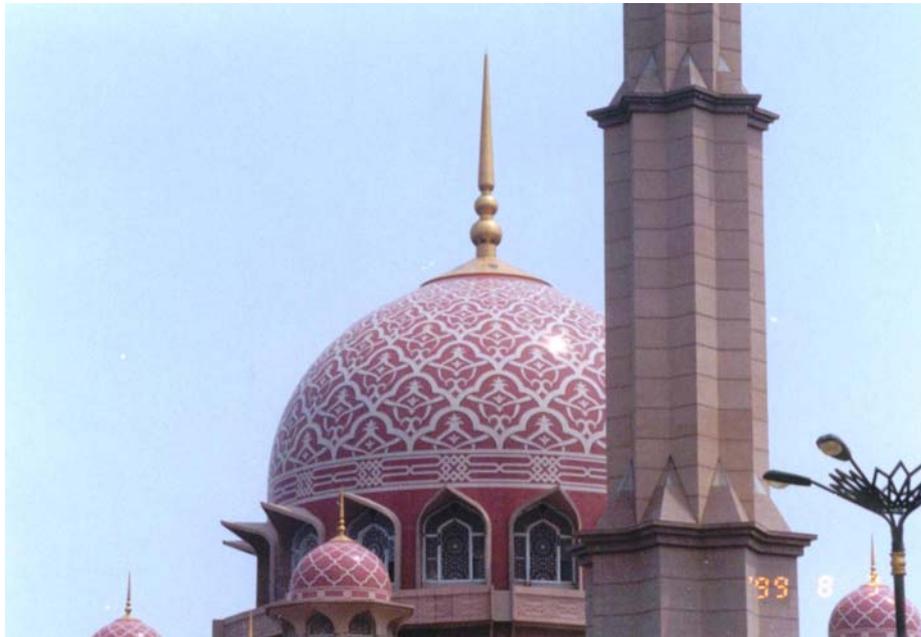
Another Helita Pulsar ESE air terminal was also installed on the apex of the spire erected on the dome of the mosque (Figs. 3 and 4). This indicates that the ESE air terminal that was installed on the minaret was designed for the protection of the minaret only.

Figure 3: The dome of the Putra Mosque.
